**PHASE I REPORT  
NATIONAL DAM INSPECTION PROGRAM**

**NAME OF DAM:** Elroy Face Dam  
**STATE LOCATED:** Pennsylvania  
**COUNTY LOCATED:** Indiana  
**STREAM:** An Unnamed Tributary of Yellow Creek  
**SIZE CLASSIFICATION:** Small  
**HAZARD CLASSIFICATION:** Significant  
**OWNER:** Eastern Orthodox Foundation  
**DATE OF INSPECTION:** November 28 and December 12, 1979

ELROY FACE DAM  
NDI I.D. PA-281  
NOVEMBER 28, 1979

PHASE I REPORT  
NATIONAL DAM INSPECTION PROGRAM  
ELROY FACE DAM  
NDI I.D. PA-281  
DER I.D. 32-56

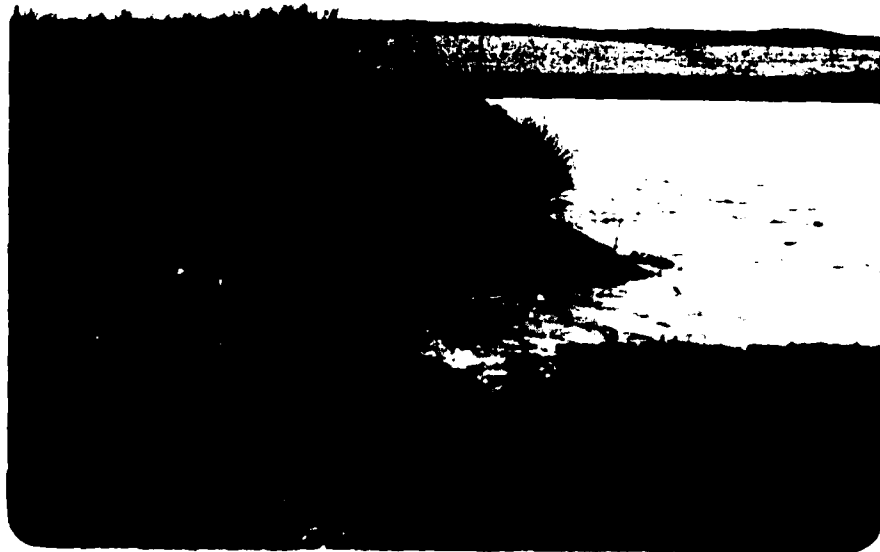
VISUAL EXAMINATION OF	OBSERVATIONS	REMARKS OR RECOMMENDATIONS
CONCRETE WEIR	A 29-foot-wide masonry structure in poor condition.	Major repairs are required.
APPROACH CHANNEL	Submerged. It appeared to be free of debris.	
DISCHARGE CHANNEL	An earth channel with no erosion protection. In poor condition.	The discharge channel should be provided with erosion protection.
BRIDGE AND PIERS	None

Photograph No. 3  
Emergency spillway.

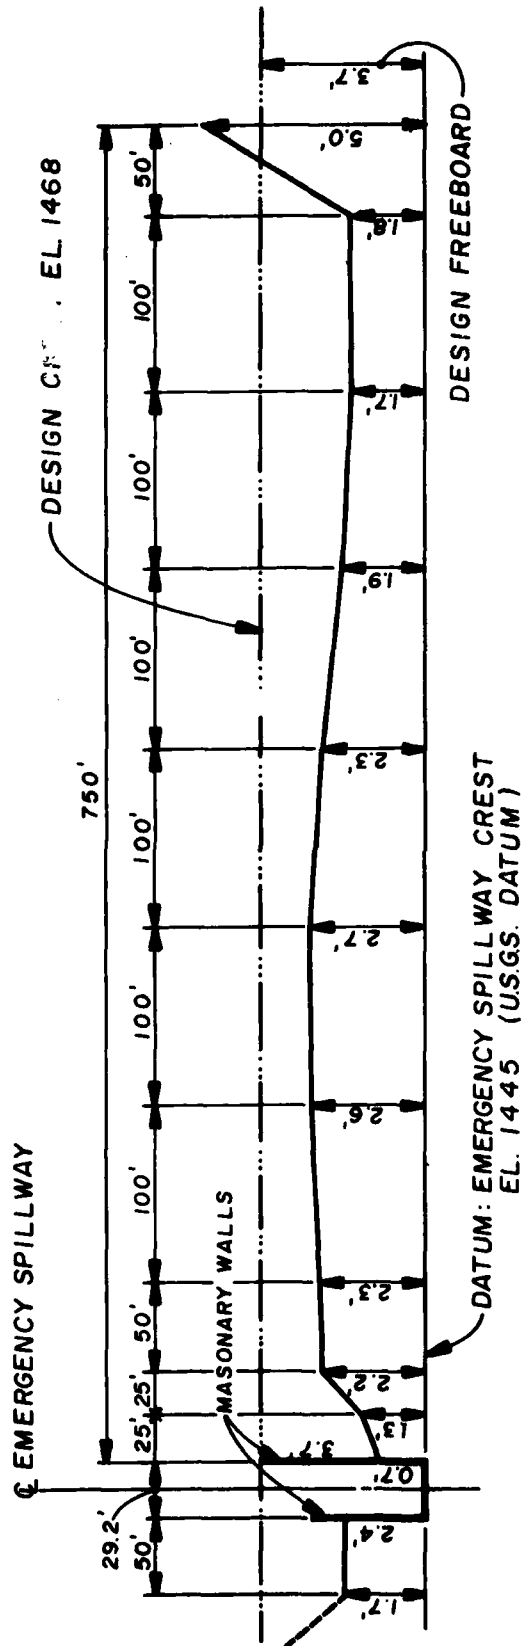
# **DAM CREST PROFILE** (LOOKING DOWNSTREAM)

A preliminary survey of the crest of the dam indicated that the remaining portion of the crest is also below the design level by about one to two feet.

The top of the dam was surveyed relative to the emergency spillway crest and was found to be very irregular. The crest profile of the dam is illustrated in Plate 7.
